# Wisconsin Lakeshore Restoration

## The Wisconsin Lakeshore Restoration Project: A Growing Solution to Degraded Shorelines

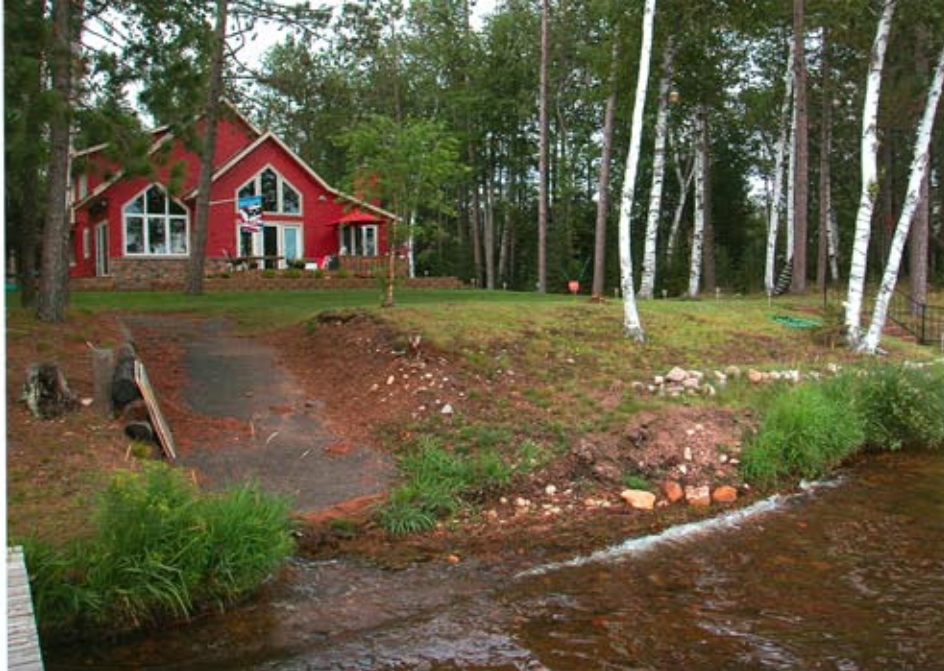
Figure 1. Hvam site on Found Lake before shot; notice spotty turf grass, exposed soil, and erosion problem caused by asphalt boat access.

Another aspect of the project had DATCP staff leading a team in designing shoreline erosion control treatments for some property owners. The team worked together on testing the effectiveness of different treatments on several Found Lake sites, from biologists to ShoreSox®, EnviroLok® bags to soil lifts, rain gardens to straw matting (see Figures 1 and 2).

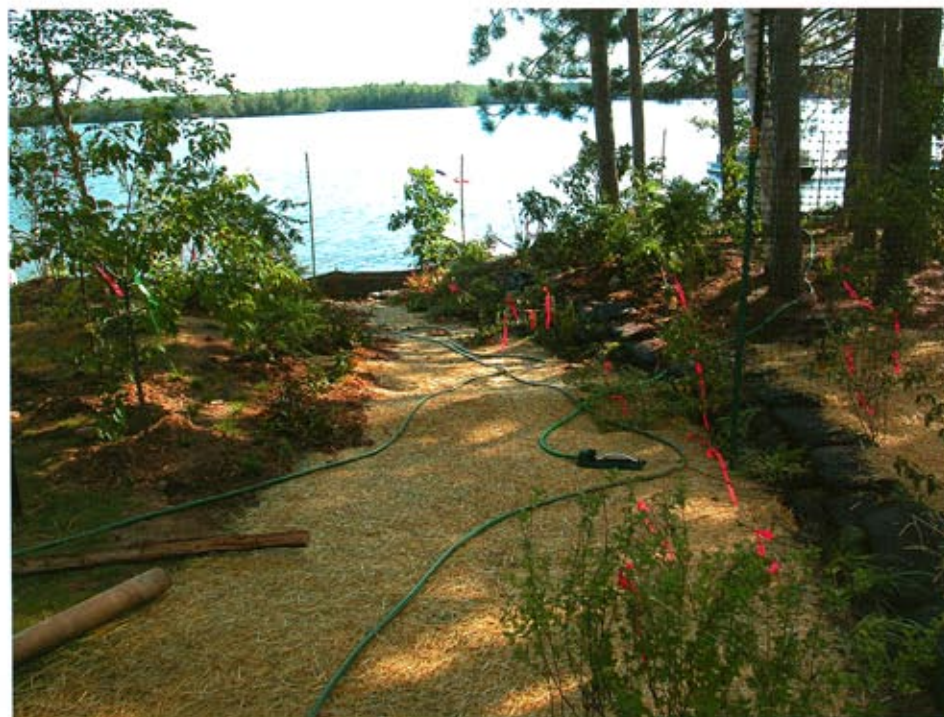
Figure 2. Hvam site on Found Lake after shot; straw matting with native seed mix woven in replaces boat access and other erosion control and native species plantings in 2008 field season.

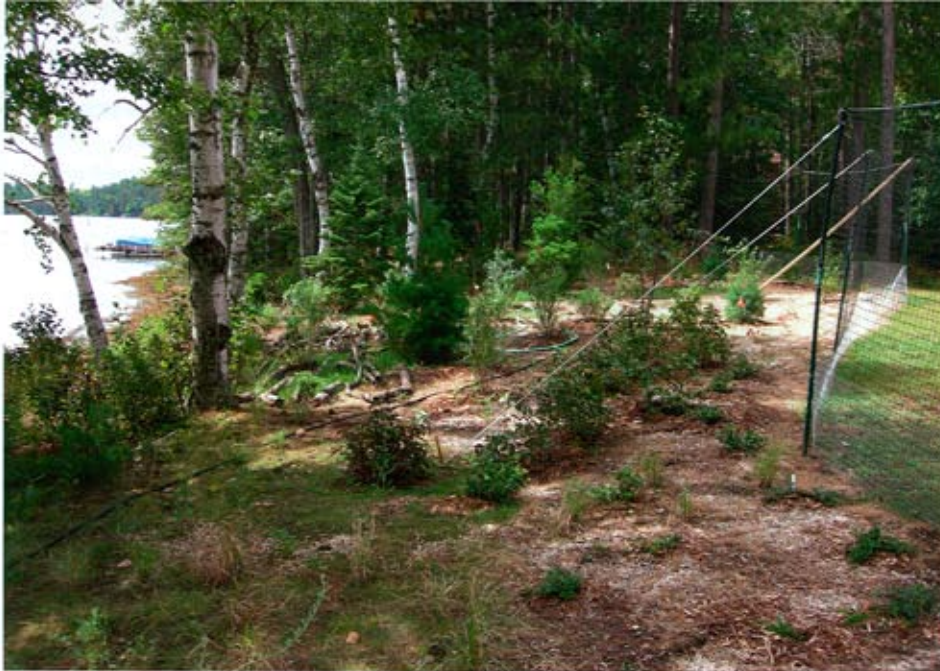
Figure 3. Kobelt site on Found Lake post planting in summer 2007; note woody material plots next to paper birch trees.

plots, varying the percentage of woody material area cover from high (50%), to low (25%), to no cover. Woody material was defined as branches  $\geq 2.5$  cm and  $\leq 10$  cm in diameter and  $\leq 3$ -meter in length. It was acquired from a recent logging site nearby (see Figure 3).
